Manhole Inspection Summary

Manhole # S37EE_019MH

Location Address: **439 PRESTON ST**

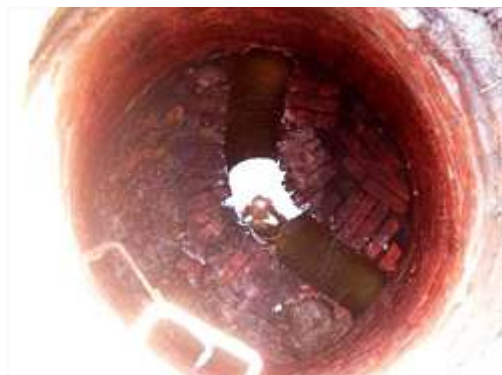
Top View

Corroded steps. Evidence of surcharge - Bench debris.

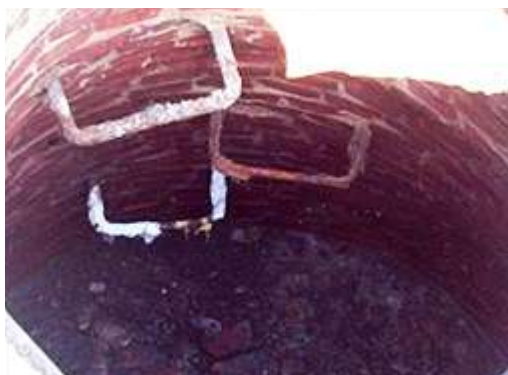
Defect

Barrel infiltration. Corroded steps.

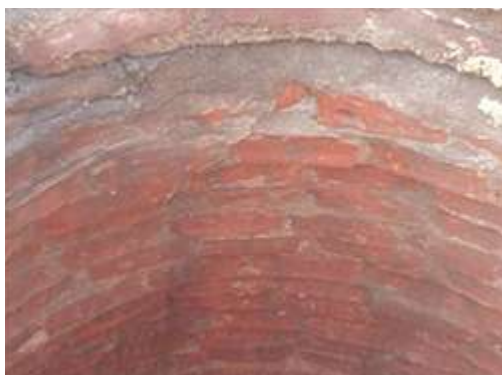
Defect

Adjustment deterioration and infiltration.

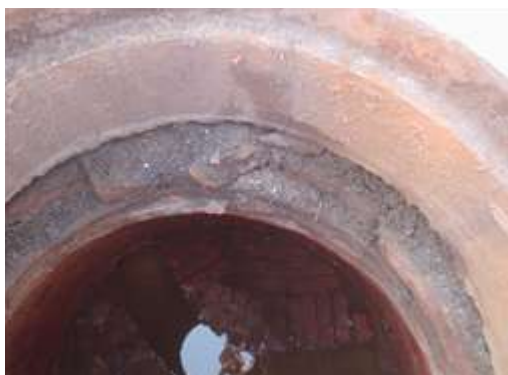
Defect

Frame leaks. Frame offset. Adjustment deterioration, loose brick and infiltration.

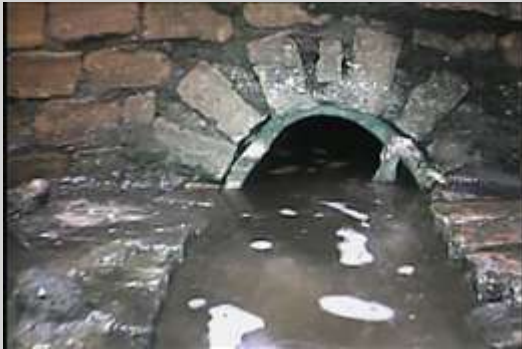
8 in. Circular Gravity Sewer Pipe Out @ 12 O'Clock

Deposits: ☐ None ☐ Mud ☐ Sludge ☒ **Debris** ☐ Grease

Infiltration: **Evidence** Pipe Seal Cond: **Broken**

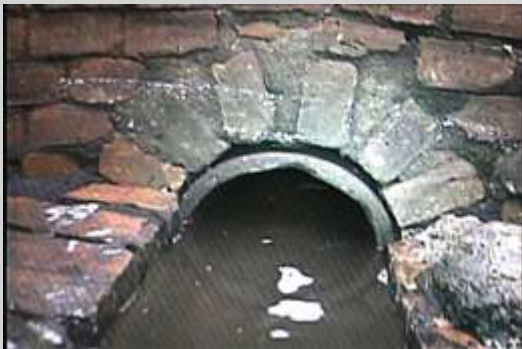
8 in. Circular Gravity Sewer Pipe In @ 4 O'Clock

Bench deterioration.
